MIGRATION OF A BROKEN CERCLAGE WIRE FROM THE PATELLA INTO THE HEART

A CASE REPORT

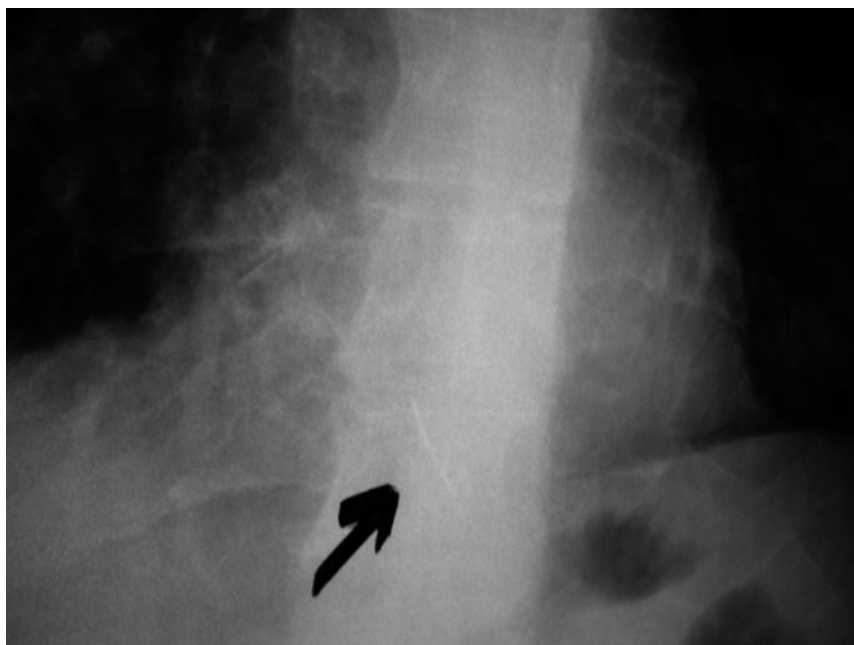
Plain anteroposterior (Fig. 1-A) and lateral (Fig. 1-B) radiographs demonstrating the fragment of cerclage wire in the right ventricle of the heart (black arrow).

A forty-seven-year-old man underwent a barium swallow to evaluate gastroesophageal reflux due to a hiatal hernia. The radiographs demonstrated a metallic wire in the right ventricle of the heart (Figs. 1-A and 1-B). The clinical history revealed that the patient had undergone surgery with use of

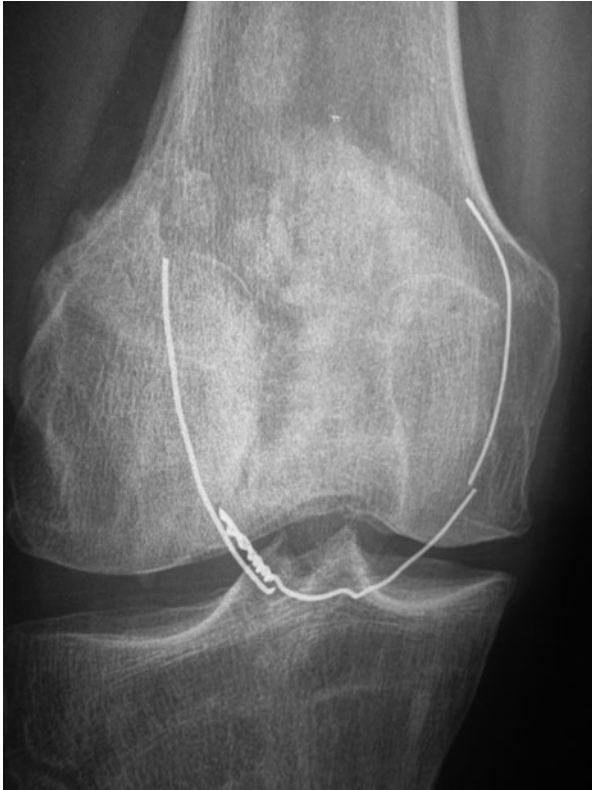
Fig. 2
Radiograph of the right knee, showing the absence of the superior portion of the cerclage wire.

We obtained the piece of wire that had been removed from the heart and matched its length with the gap shown on the knee radiograph, at which time we noted that another piece of cerclage wire was missing. Additional radiographic evaluation showed that the missing piece of wire was located in the deep crural fascia of the ipsilateral leg. We then surgically removed all of the residual hardware from the right patella and from the calf region.
